Defective phenomenon:

L3 crack

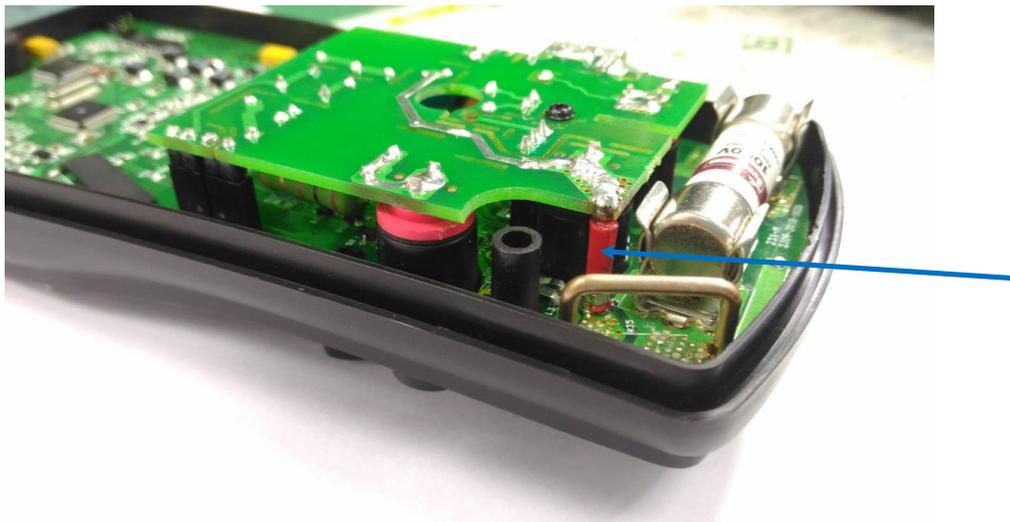
1. We were using the strength much much more than the ones which users may apply for fuse replacement to push PCB module several times for three units.
2. We then use microscope to check their L3 & L2 but did not find their solders were with any crack clue.
3. We then disconnected the wire indicated by blue line below and repeated above tests again. Then we found one unit is with crack sign.

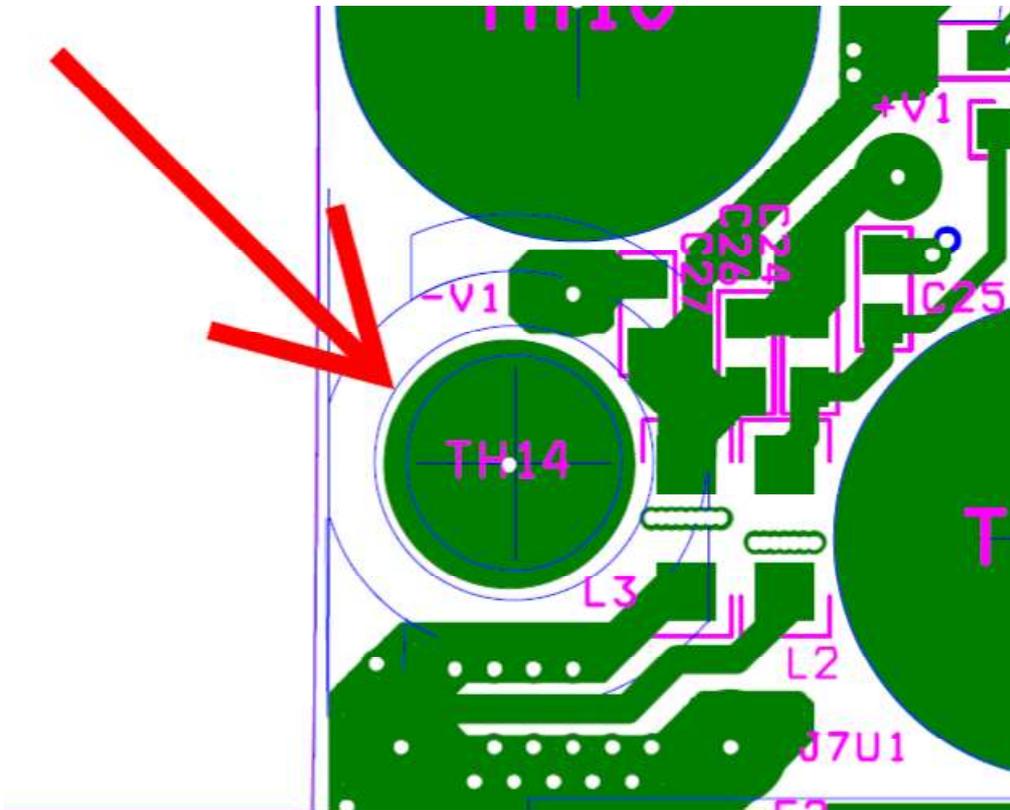
1. We think L3 crack problem should not be from fuse replacement. It is because the wire, connecting main PCB module and terminal PCB module, limits the deformation of main PCB module during fuse replacement.
2. Our Production Procedures are:
  - 2.1 To assemble main PCB module to case.
  - 2.2 To put fuse to main PCB module.
  - 2.3 To solder the wire connecting main PCB module and terminal PCB module.We think L3 crack could be from Production Procedure 2-2.
3. Another possible cause is "L3 was soldered to left trend". Please see the drawing below. The blue circle indicated by red line is the outer edge of lower case boss. If L3 was soldered to left trend, it may be pushed by that boss after the assembly of upper and lower cases. That could crack L3 too.

1. To change Production Procedures as followings:
  - 1.1 To assemble main PCB module to case
  - 1.2 To assemble terminal PCB module
  - 1.3 To solder connected wire before putting fuse to main PCB module
2. For semi-finished or finished units, to check if L2 & L3 are with crack sign. If yes, replace it.
3. To slightly cut that boss to avoid pushing L3 after the assembly of upper and lower cases.

1. To move L3 downward slightly.
2. To add ribs to two bottom corners of upper case to prevent deforming main PCB module too much during production or fuse replacement.
