Project Yaigol

Part 4. Other Power Supplies

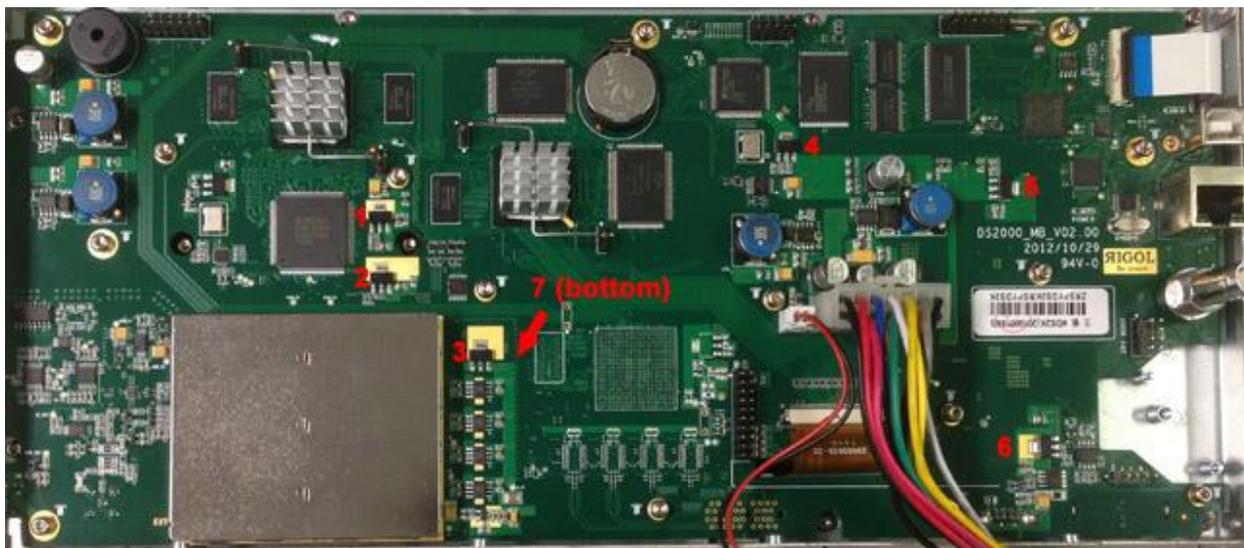
I still had the front panel attached so I could only have access to the PCB top side. The board has seven of 1117 LDO regulators marked in **Red** in this landscape photo. Six regulators on top and one (#7) on the PCB bottom:

- **All 1117 LDO regulators in DS2072A were oscillating.**

1. +2V ADC Digital
2. +2V ADC Analog
3. +3.3V Trigger stage
4. +1.5V
5. +1.4V
6. +5V
7. +5V Input Attenuator control (located on PCB bottom side)

- Replace the LDO output ceramic capacitor with a tantalum 10uF 10V...16V capacitor (observe the tantalum capacitor polarity). Use the landscape board photo at the beginning of this section to locate LDO regulators #1 to #6 on the PCB top and #7 on PCB bottom.

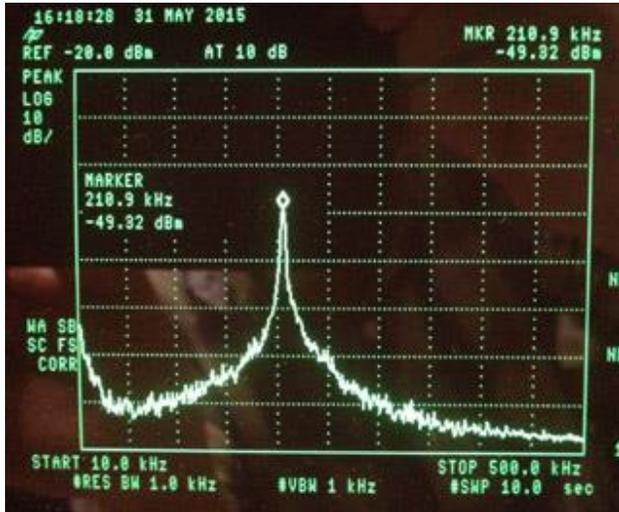
LDO #1 Before

I started from #1 and #2 which are the ADC DVDD and AVDD +2V regulators. I checked the output rails with the spectrum analyzer, sure enough they were bad bad bad. I went ahead and replaced the output ceramic caps. Here is the screenshots for #1 and #2 before and after the fix:

Mind you those are the ADC power regulators. Do I need to repeat? The ADC power regulators. The screenshots on the left are what you have in your Yaigol now. The pictures on the right is what you will have after you do the fix. You gain a 40dB improvement in ADC supply noise.

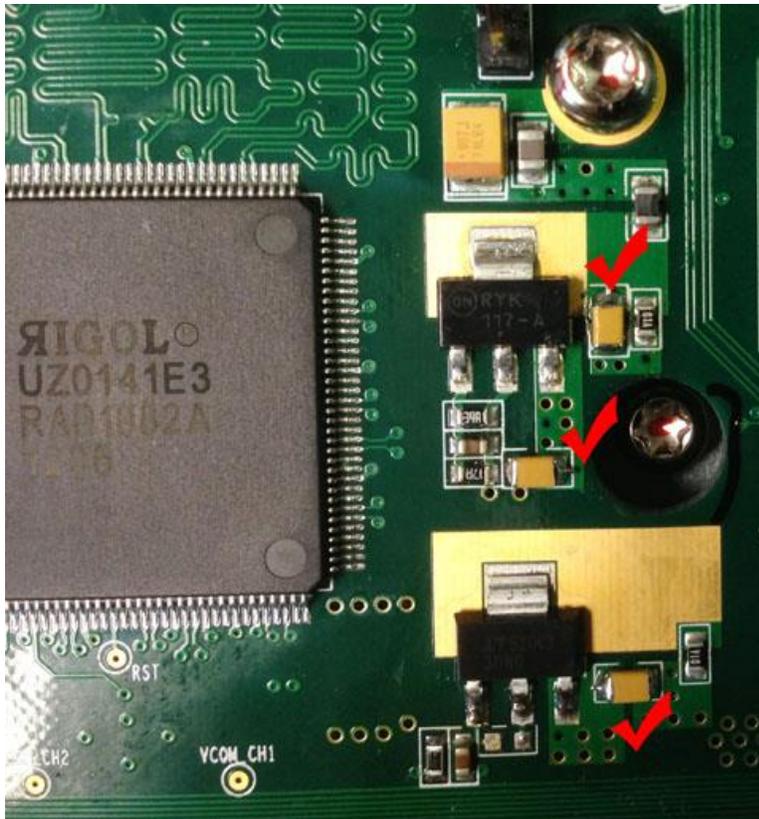
For your reference here is a photo of LDOs #1 and #2 with the output capacitors replaced with tantalum caps:

It seems I also replaced the input capacitor on LDO #1 for some reason, perhaps I saw it improved noise at the LDO input. I also replaced the LDO #2 (ADC Analog VDD) with a low noise LT 3080 adjustable regulator. You do not have to do this. I just attempted to minimize ADC supply noise as much as possible. LT1038 requires only one set resistor, so I removed one of the divider resistors and replaced the other with a new value calculated using the formula in the [datasheet](#).

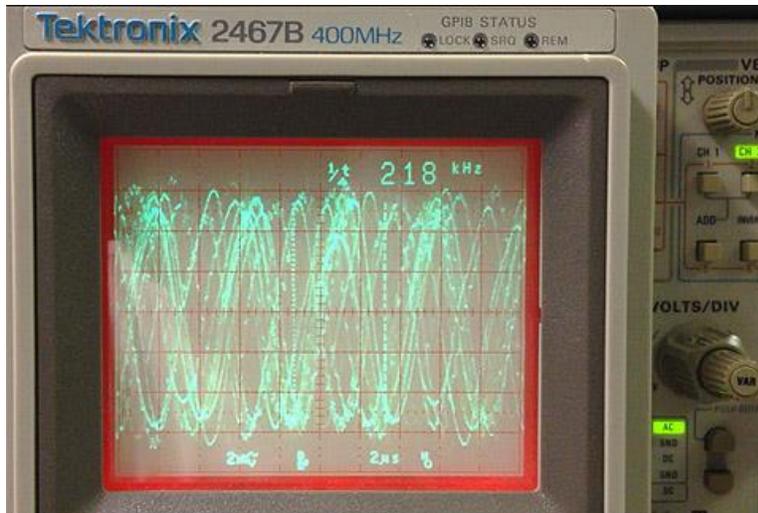
If you look again at the landscape photo of the annotated board, there are 5 more voltage regulators under the LDO #3, four in SOIC-8 and one in small SOT23 package. Those are the input stage power regulators. They are low ESR tolerant parts and did not oscillate but they shared the input +6.3V rail with the LDO #3, and that 6.3V rail was horribly oscillating at about 220kHz and some of it passed right through the input stage regulators and into the scope analog front-end. In fact it was the worst oscillation out of all I have seen so far in this crappy scope. Here is a screenshot of the 6.3V shared rail:

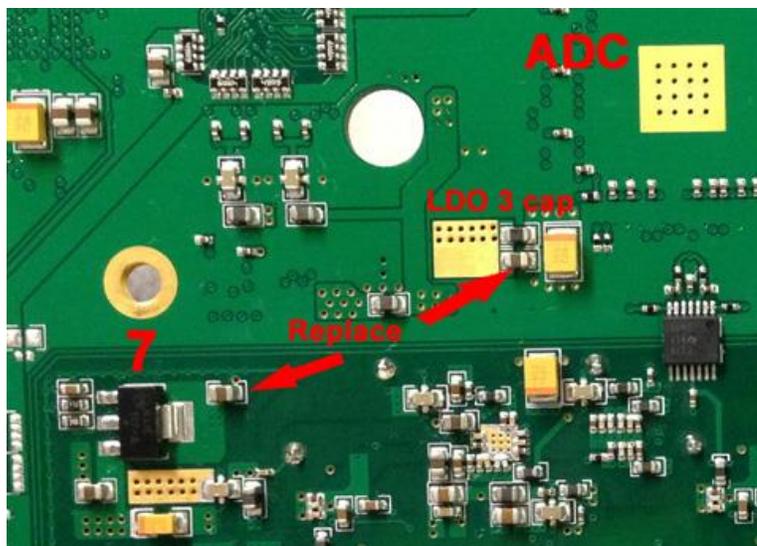
Sadly, there was no capacitor seen at LDO #3 output on the top side of the PCB. Was it on the bottom side? There was no choice left so I had to take the front panel off and sure enough there it was. And to my enjoyment there was another regulator (LDO #7) on the bottom:

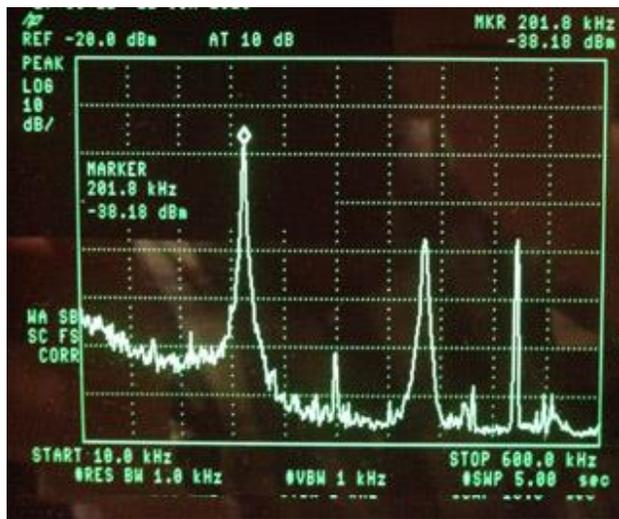
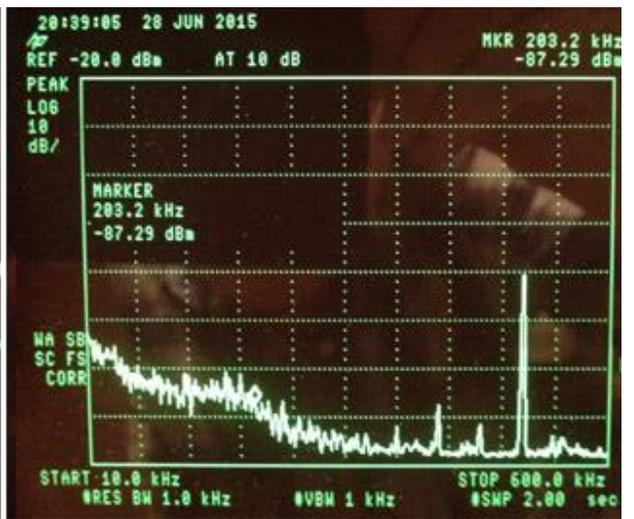
Shared +6.3V rail

Here is screenshots of the 6.3V shared power rail before and after the fix. To remind you again, all regulators for the analog front-end were sitting on that rail. The two leftmost peaks in the left picture is the oscillation cause by the LDO #3 and #7 output caps. I observed that the two peaks were moving back and forth as the oscilloscope started up, performed startup check and went to acquisition state. Evidently, frequency of oscillation depended on the load on the rail. And this can happen because variations in consumed power cause variation in the load impedance and that affects the regulator's feedback loop. The rightmost third peak was not caused by LDO oscillation; it was a leftover from the upstream switching power regulator working at 500kHz switching frequency. It was not affected by the caps swap and remained on the rail after the change as can be seem in the right picture.

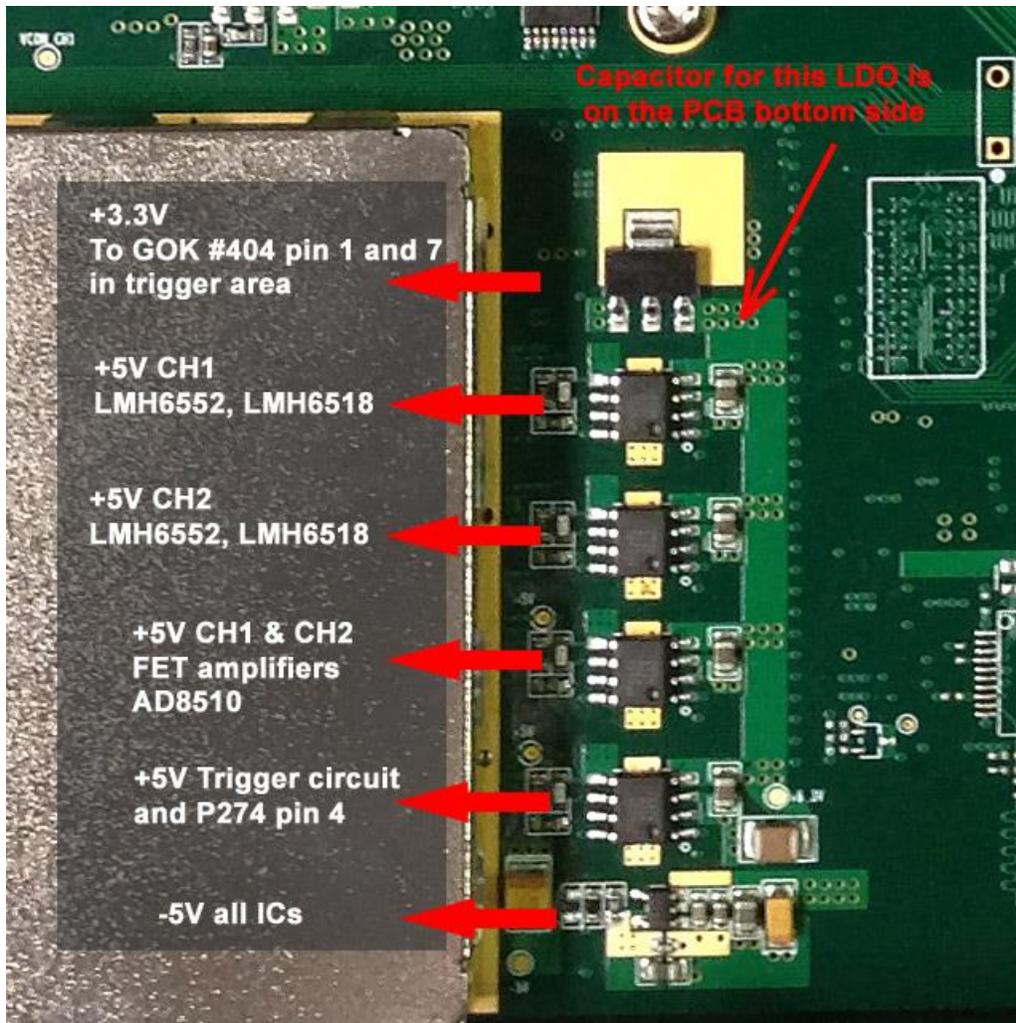
The following photo shows the power regulators for the analog input stage. Beside the top 1117 LDO, they are specified to work with ceramic capacitors and did not oscillate themselves, however before the fix they all had attenuated oscillation passing through them from their input 6.3V rail.
